Management Plan for Asbestos Containing Building Materials

Cedaroak Park Primary
4515 S. Cedaroak Dr.
West Linn, OR 97068

TRE Project No. 1020-90

ASBESTOS MANAGEMENT PLAN

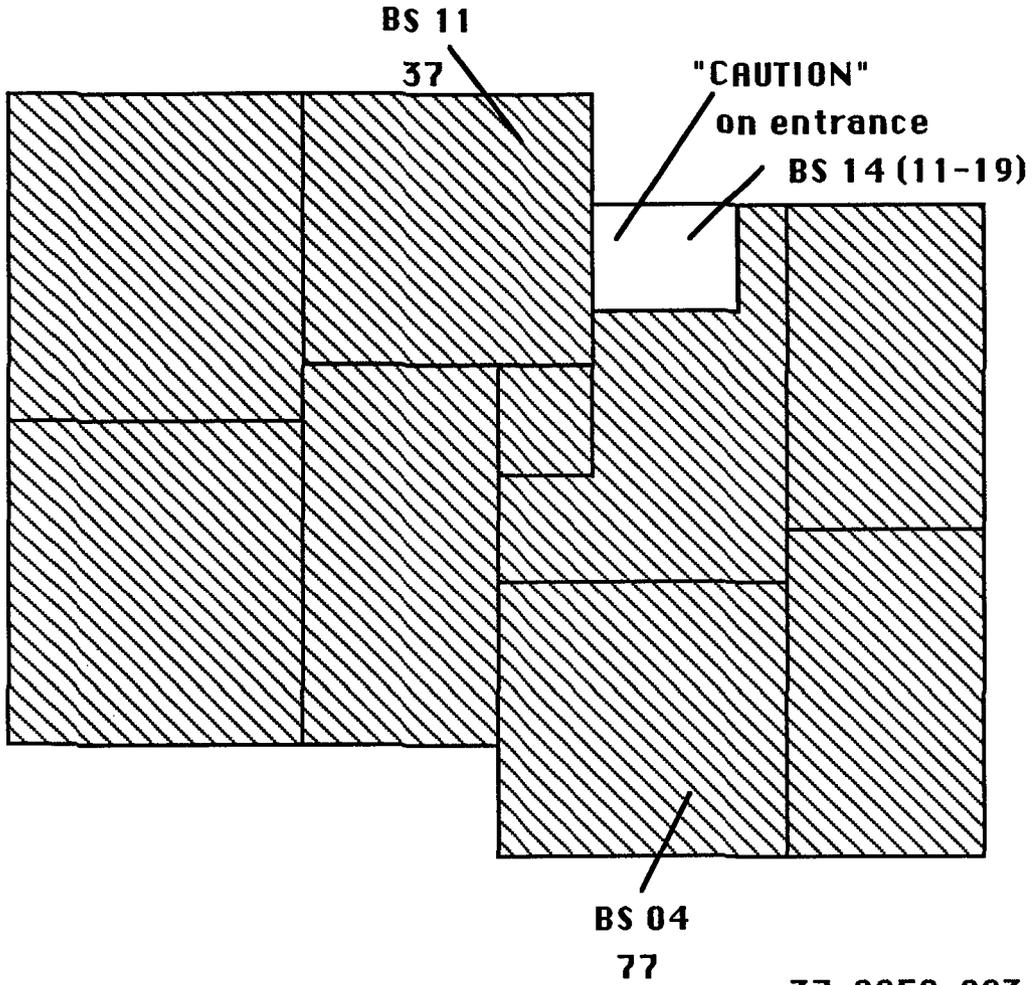
37-0050-003-001
CedarOak School
Rooms 17-23

ASBESTOS-CONTAINING FLOOR TILE

ALL FLOOR TILE AND SURFACING MATERIAL CONTAIN ASBESTOS

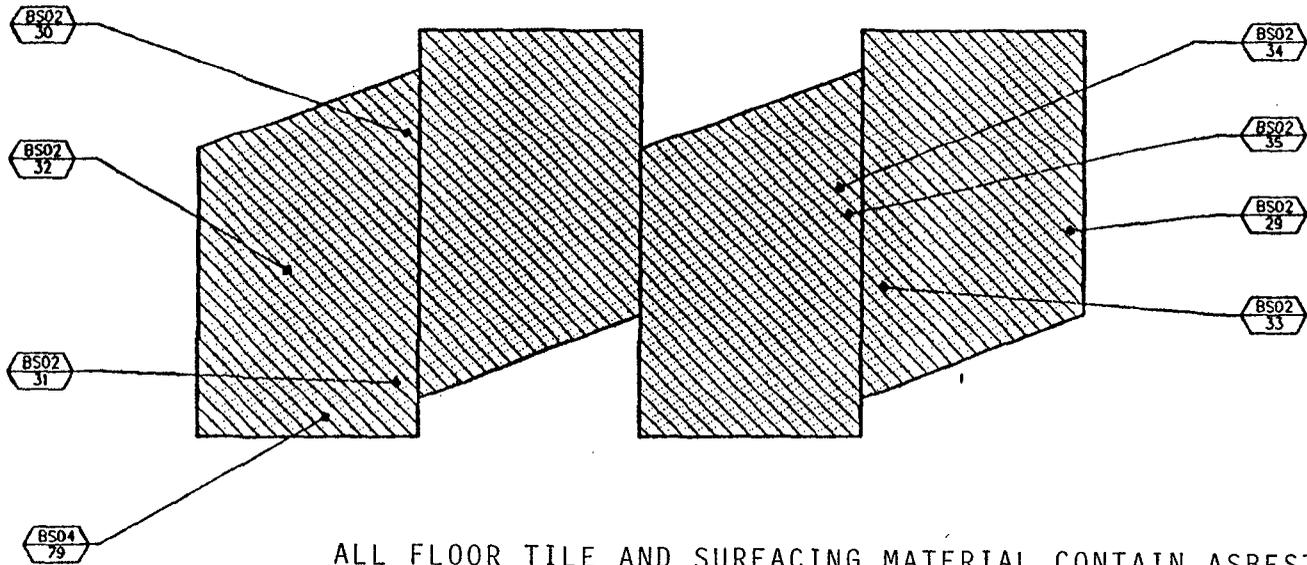
ROOMS 1-4

ALL FLOOR TILE AND SURFACING MATERIAL CONTAIN ASBESTOS

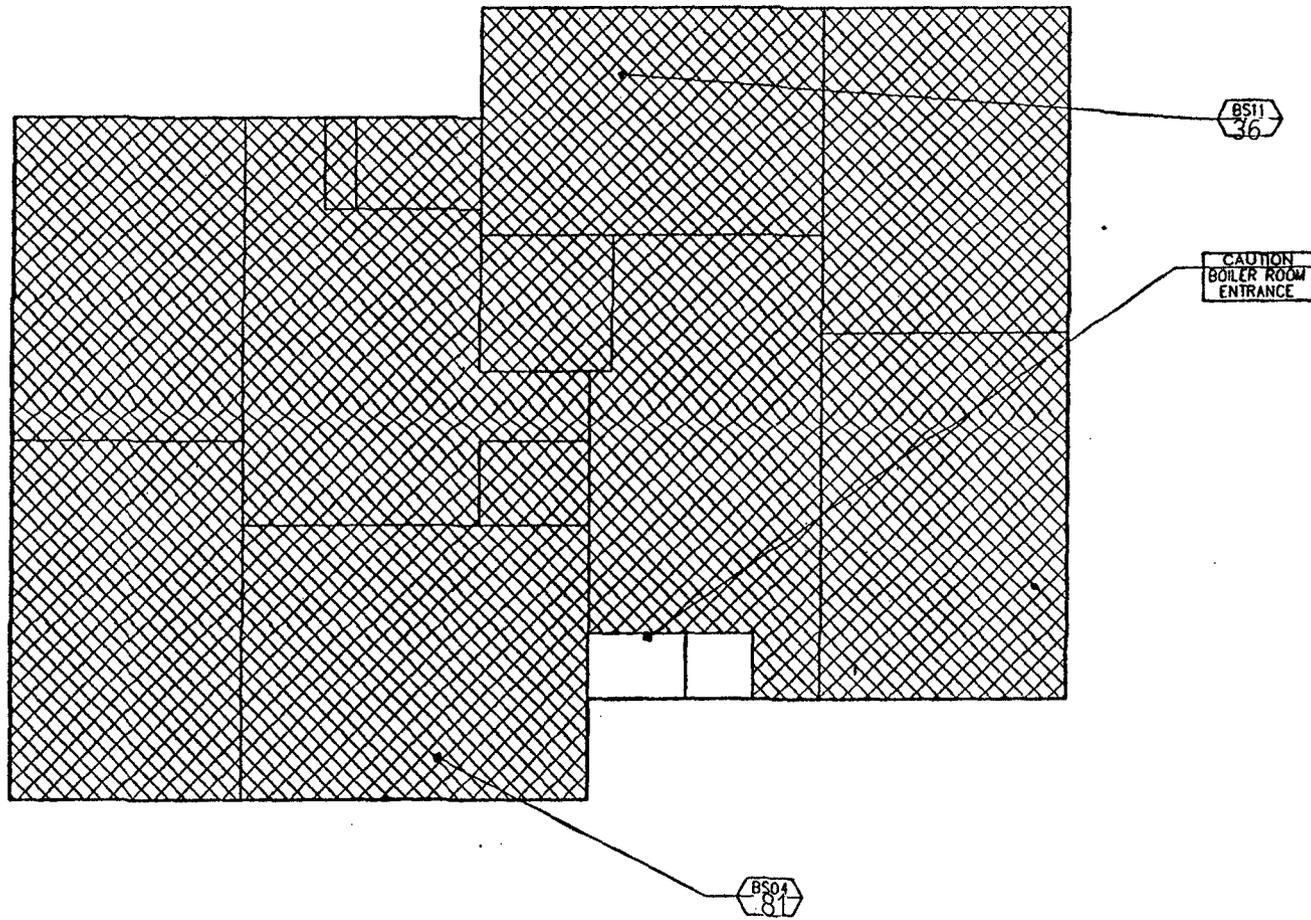
ROOMS 11-16

ALL FLOOR TILE CONTAINS ASBESTOS

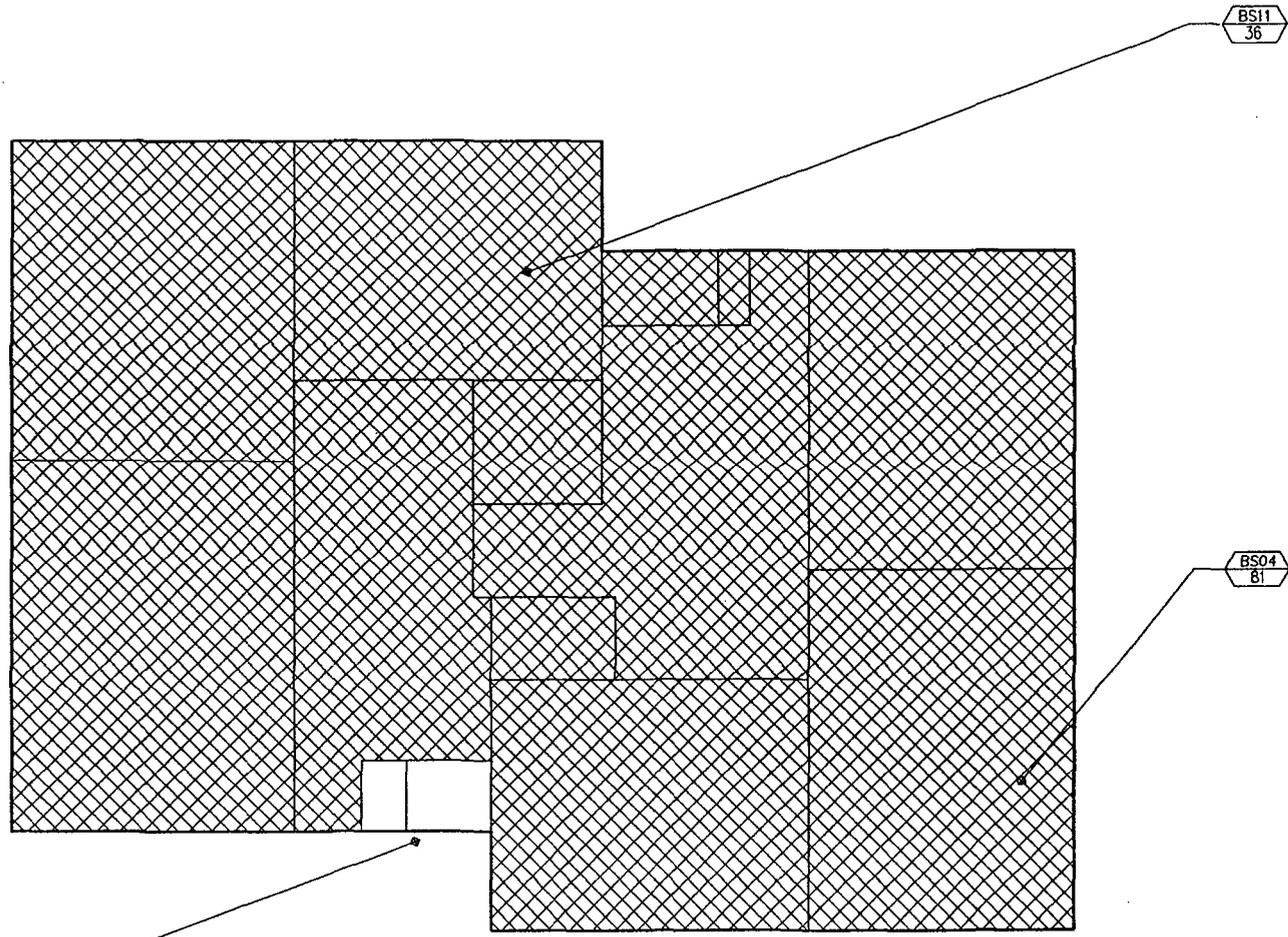
CAUTION
BOILER ROOM
ENTRANCE
